MISCELLANEOUS PAPER GL-80-11

## BONDED CONCRETE OVERLAYS: CONSTRUCTION AND PERFORMANCE

Michael I. Darter, Ernest J. Barenberg

September 1980  
Final Report

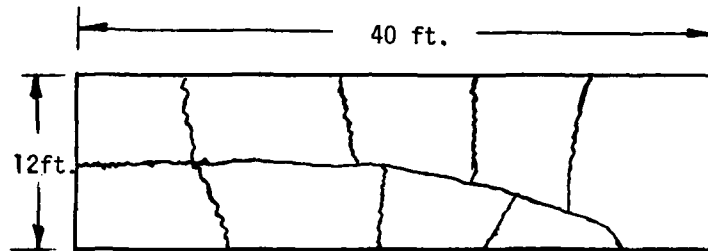
Figure 2.1. Diagram of Cracking Existing in Slab Before 4-in. Bonded Overlay was Placed in Clayton, Co., Iowa in 1977.

Performance of bonded concrete overlays on pavements in service has demonstrated the need for repairing any areas of localized breakup. If not patched, these areas will quickly reflect through thin overlays (e.g. < 4 in.).\* Thicker overlays may delay the breakup for several years, but all cracks in non-reinforced slabs will eventually reflect through, especially under heavy traffic. Figures 2.1 through 2.5 illustrate some reflective cracking through thin-bonded overlays. The base slab was non-reinforced.

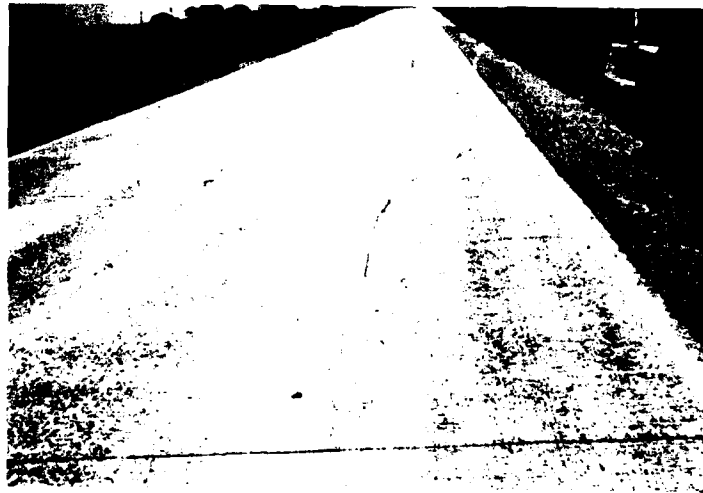
Figure 2.2. Reflective Cracking in 1979 on Slab Shown in Figure 2.1, View 1.

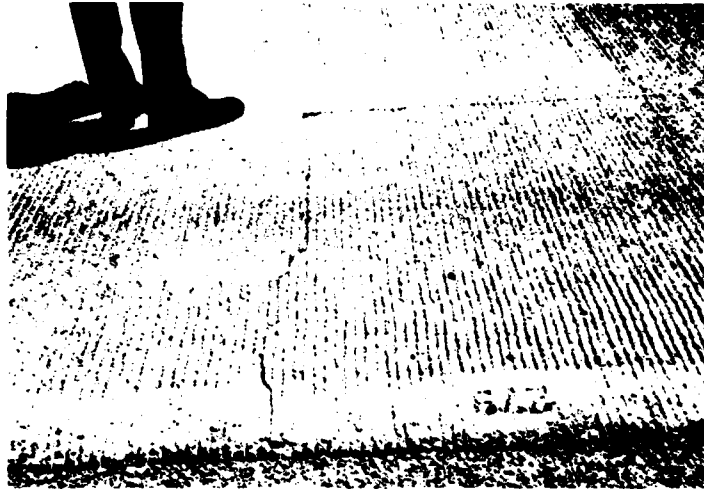
Figure 2.3. Reflective Cracking in 1979 on Slab Shown in Figure 2.1, View 2.

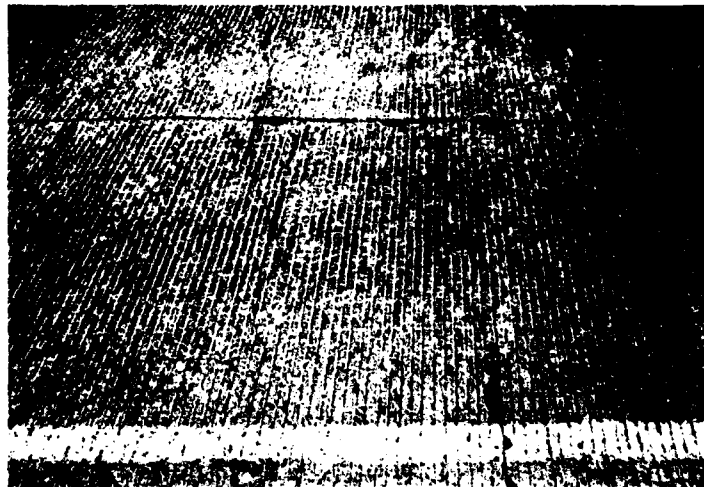
Figure 2.4. Reflective Cracking in 1979 on Slab Shown in Figure 2.1, View 3.

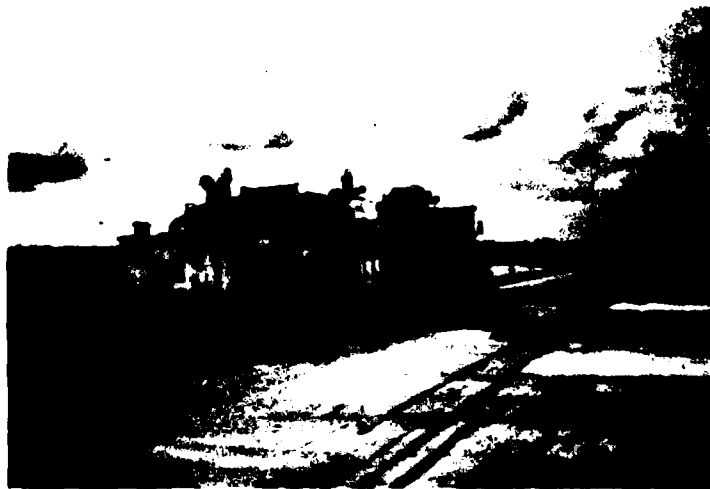
Figure 2.7. CMI Roto-Mill Used at Willard Airport, Champaign, Illinois in 1978.

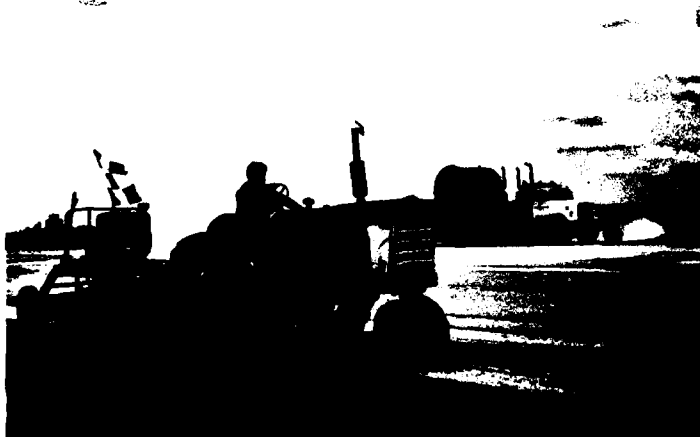
Figure 2.9. Brooming of Roto-Milled Surface (Foreground) and Water Blast Cleaning of Surface (in Background) at Willard Airport.

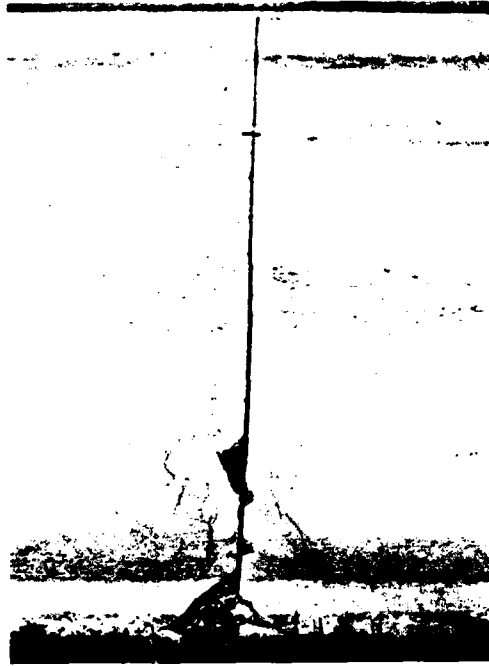
Figure 3.1. Typical Joint Showing "D" Cracking Before Overlay Was Placed at Waterloo, Iowa (Some Joints Were Worse Than This and Were Patched) 1977.

overlay are shown in Figures 3.1 and 3.2. A photograph of the overlay where, after 3 years, spalling from "D" cracking has reflected through is shown in Figure 3.3. The localized area with "D" cracking has become debonded. Thus the original slab "D" cracking has apparently continued as illustrated in a photo of a joint in a non-overlayer portion of the project in Figure 3.4. Areas of the project that were not overlaid have increased considerably in "D" cracking severity.

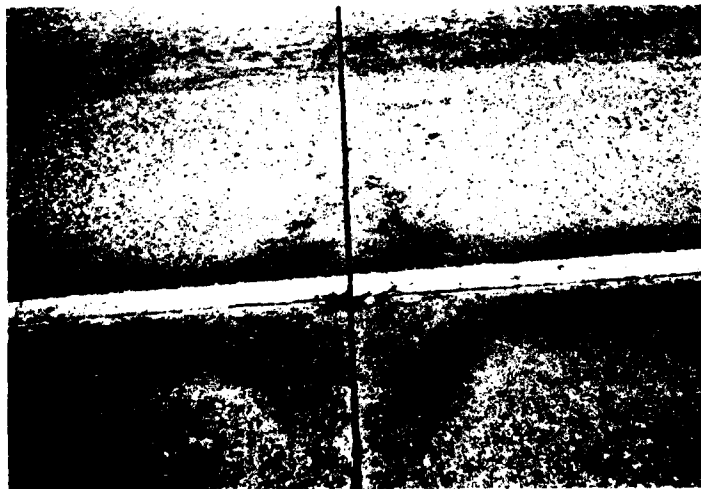
Figure 3.2. Typical Joint Showing "D" Cracking Before Overlay Was Placed at Waterloo, Iowa.

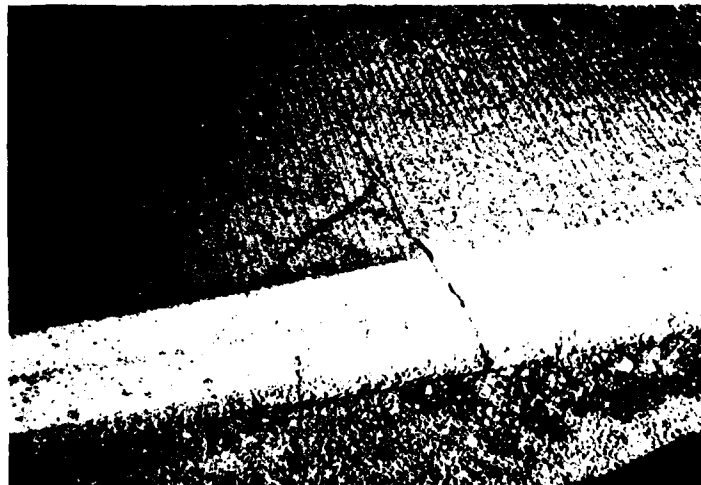
Figure 3.3. Localized Area of Debonding and Reflective Cracking of "D" Cracked Base Slab at Waterloo, Iowa, 1979.

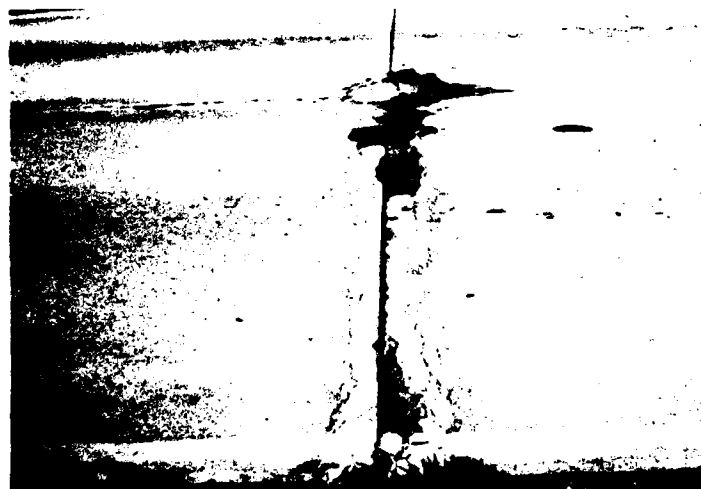
Figure 3.4. Progression of "D" Crack Deterioration in Original Slab in Waterloo, Iowa, 1979.

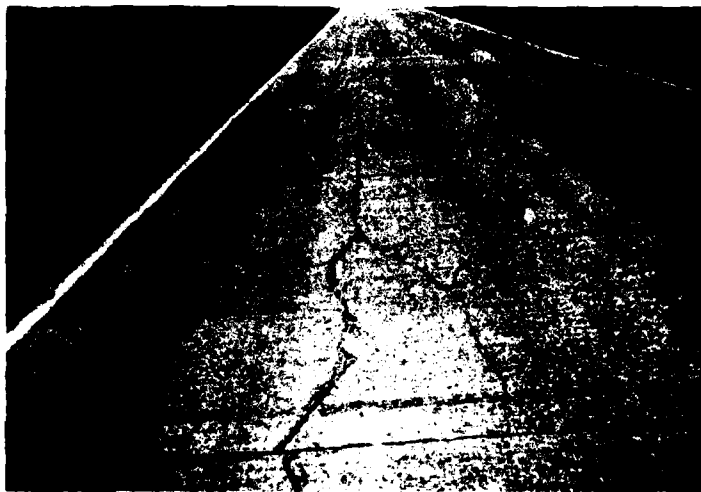
Figure 3.6. Photo of Reflection Cracking in Concrete Overlay for Slab Shown in Figure 3.5, 1979.

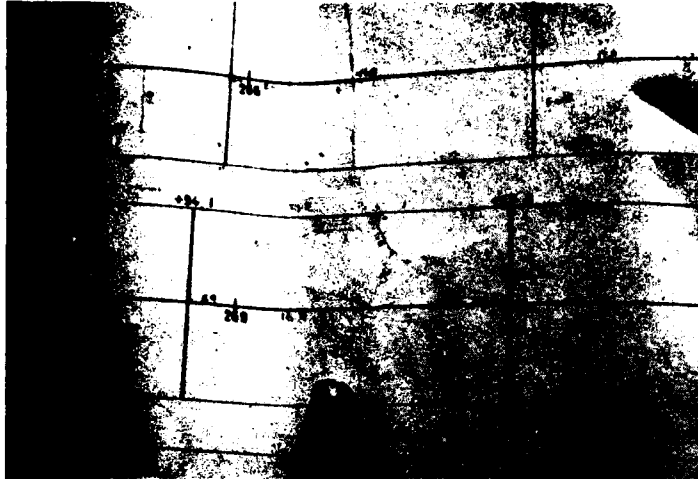
Figure 3.7. Diagram of Cracking in Base Slab at Clayton Co., Iowa, 1977.

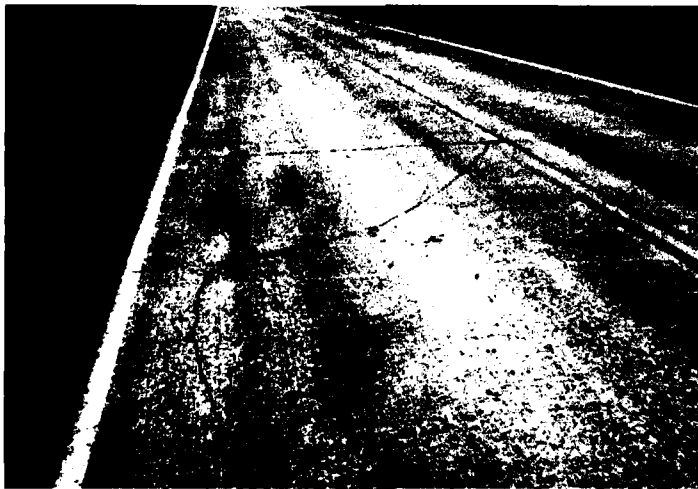
Figure 3.8. Photo of Reflective Cracking in Concrete Overlay for Slab Shown in Figure 3.7.

Longitudinal joints in the thin-bonded overlays placed in Iowa were not sawed, except for a short section on the Clayton Co. Project (Fig. 3.8). When the existing slab had a centerline joint, this joint reflected through as a crack which meandered in a narrow path near the center of the slab as shown in Figures 7.8 and 7.9. In some instances (1,2) this crack was maintained in a tightly closed position by use of tiebars placed in the

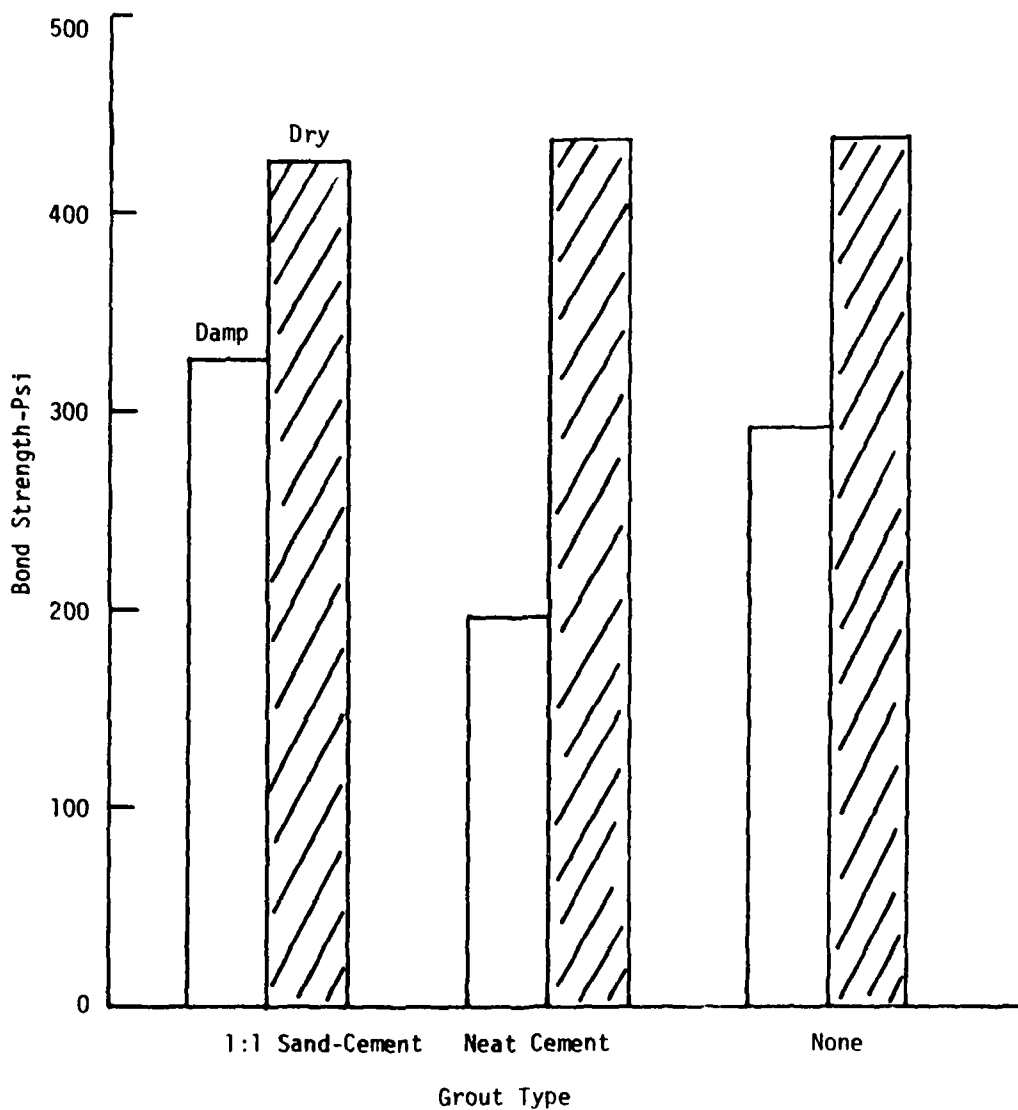
Figure 4.1. Effect of Dryness of Base Slab and Grouting on Bond Strength (Plotted from Data from Felt, 7).

The moisture condition of the surface of the existing slab can vary from dry to completely saturated. Research reported by PCA provides some basic information on the effect of the moisture on bond strengths. Concrete overlays were placed on laboratory cast base slabs that were either air-dry or damp. Data showed that better bond was generally developed with a dry surface for the base concrete than with a damp surface. Over a wide range of conditions a mean bond strength of 304 psi was obtained for the damp surface condition, while a mean of 432 psi was obtained for a dry surface condition. Figure 4.1 shows a plot of data from the studies of Felt (7). Regardless of the grouting condition, the dry surface condition resulted in a much higher bond strength (42% higher). However, it should be noted that even with the damp surface the bond strength was well above the suggested 200-psi minimum requirement.

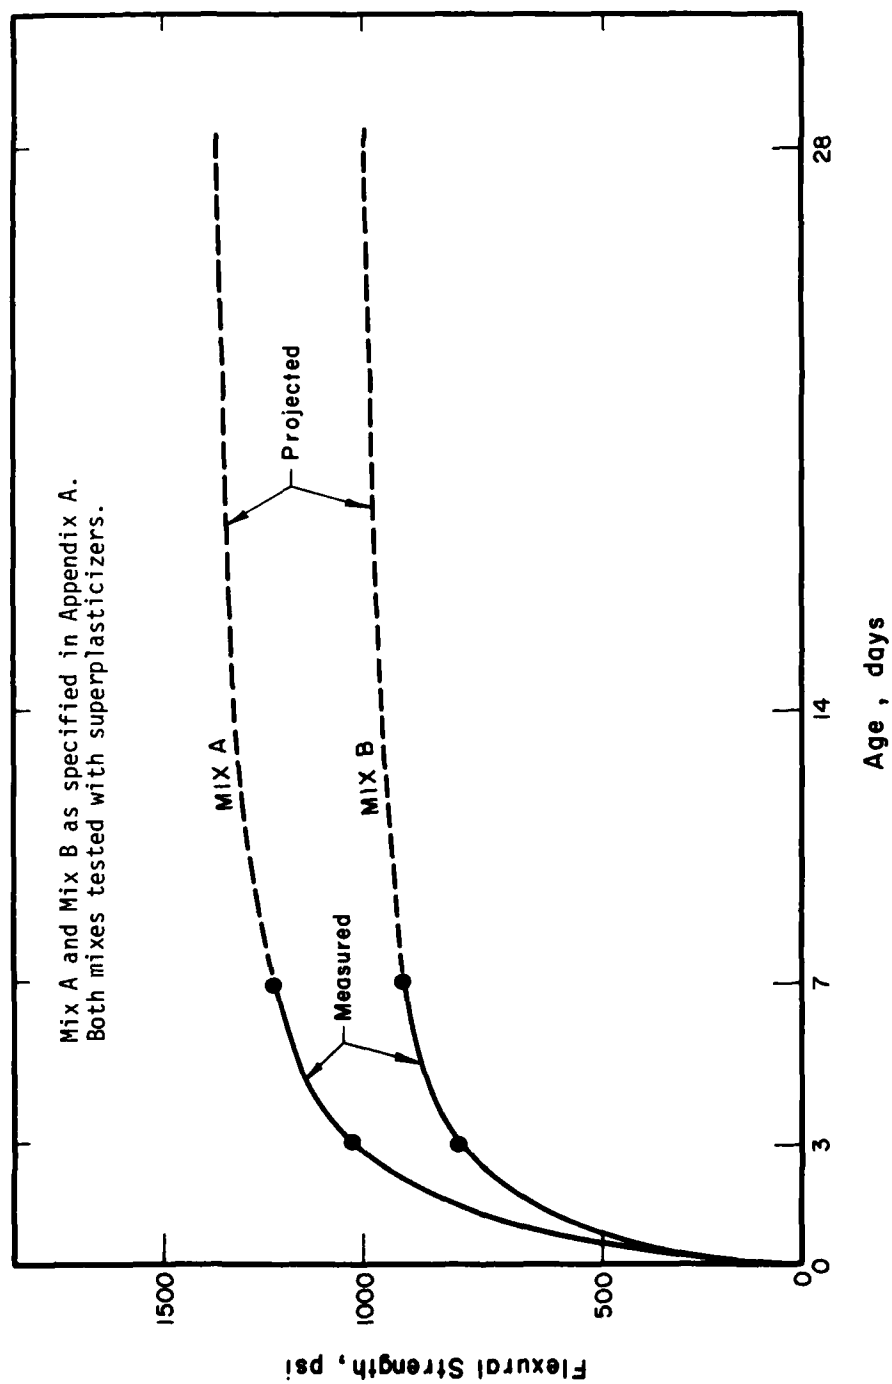
Figure 5.1. Typical Age-Strength Relationship for Concrete in Overlay on U.S. 20, Near Waterloo, Iowa (2, 3).

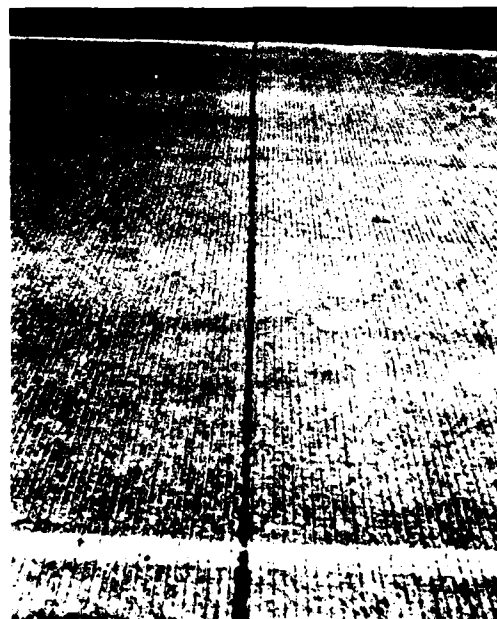
Figure 7.4. Sawed Transverse Joint in Overlay at Clayton Co., Iowa.

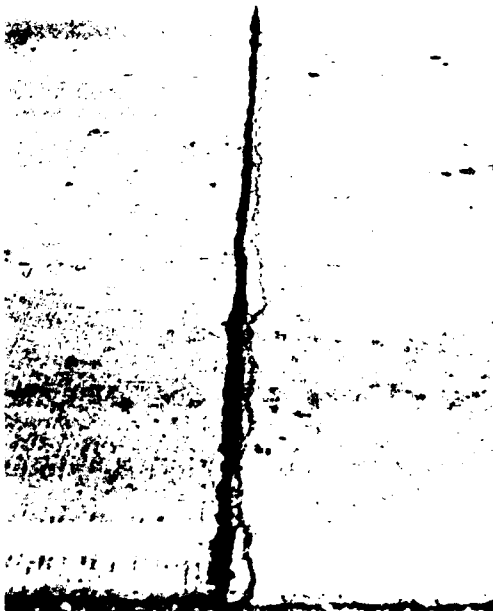
Figure 7.5. Sawed Transverse Joint  
in Overlay that has De-  
veloped a Secondary Joint  
Crack (Clayton Co.,  
Iowa), View 1.

Sawed joints in bonded concrete overlays also present some problems. Figures 7.5 and 7.6 show a sawed joint with a secondary crack adjacent to the saw cut. This type of distress appeared in over 25 percent of the sawed contraction joints in the thin overlays in the Clayton County project (2), but was found to be less severe in the thicker overlays. At Willard Airport, where the bonded overlay was nearly 8 inches in thickness, only 11 joints out of several hundred in the project exhibited the secondary joint

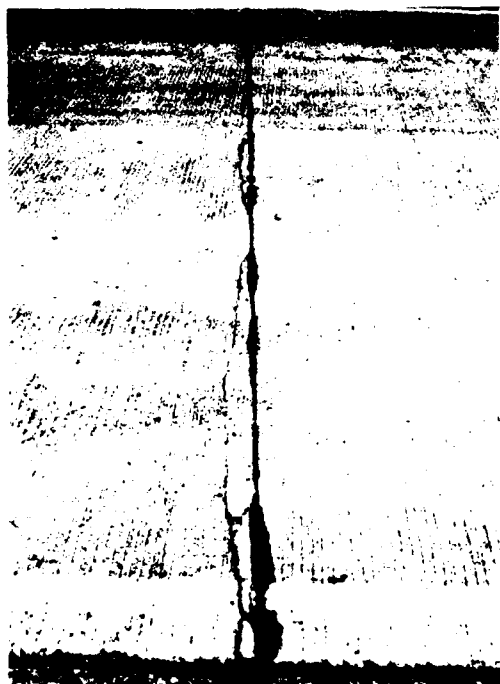
Figure 7.6. Sawed Transverse Joint  
in Overlay that has  
Developed a Secondary  
Joint Crack (Clayton  
Co., Iowa), View 2.

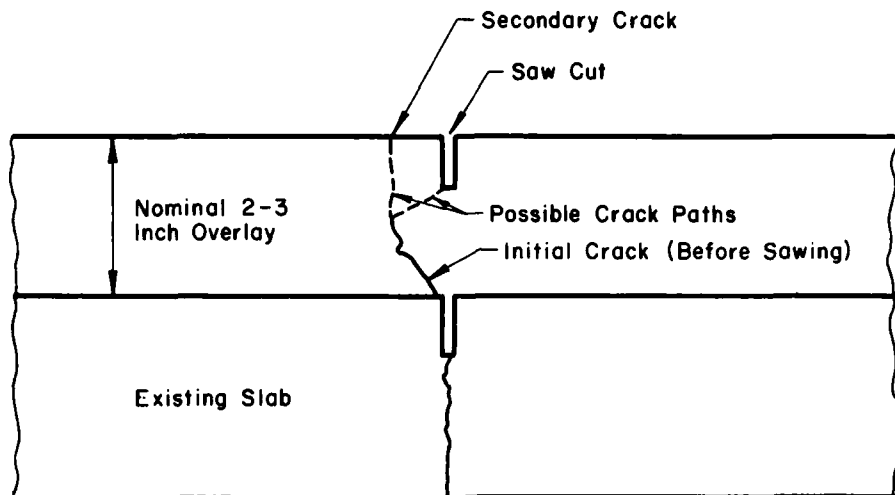
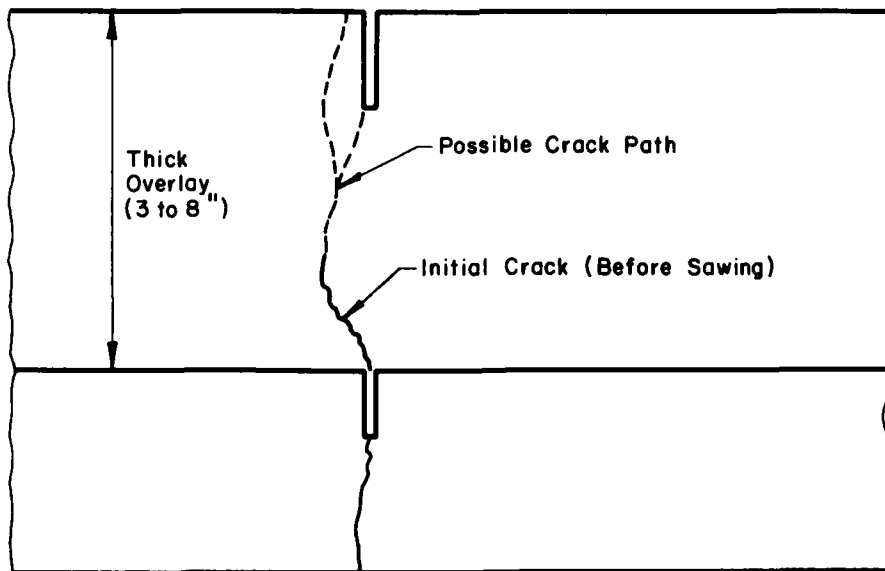
Figure 7.7. Possible Cause for Secondary Cracking.

To eliminate the secondary joint cracking problem, it will be necessary to form the weakened plane in the overlay at a much earlier age. If, as hypothesized above, the crack is initiated at an early age in the concrete, then it is probable that it will be necessary to form the joint while the concrete is still plastic. Even if an attempt is made to saw these joints at an earlier age, the crack would likely have already been initiated by the time the concrete is hard enough to permit sawing. Also, just getting

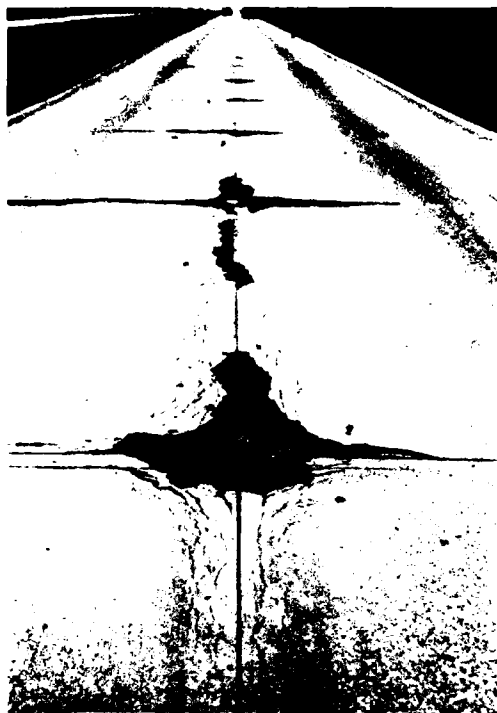
Figure 8.1. "D" Cracking in 1979 in Portions of the Original Slab at Waterloo, Iowa which were not Repaired or Overlayed.

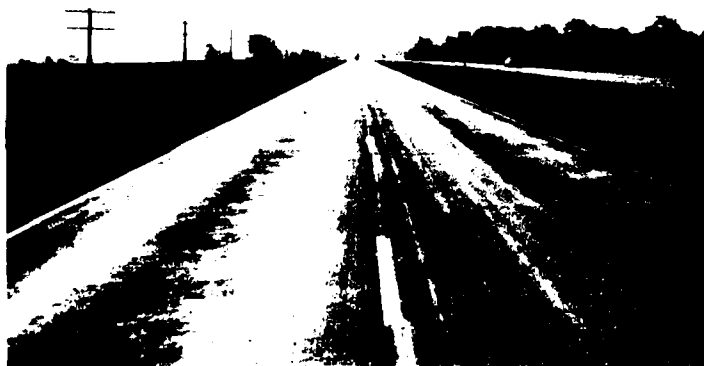
Figure 8.2. Overall View of Waterloo, Iowa Bonded Overlay, 1979.

The project near Waterloo was visited in July 1979. At that time the project was just under three years old and generally in excellent condition. The only distress in this project was at the location of several full-depth

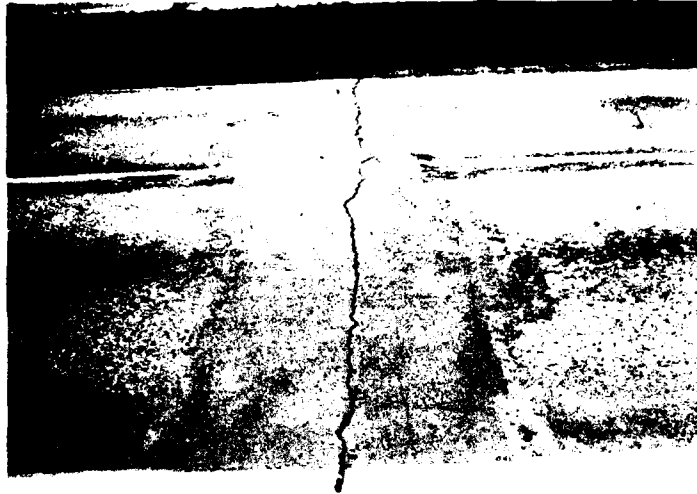
Figure 8.4a. Typical Crack Through a Partial-Depth Patch at Joint in Waterloo Project.

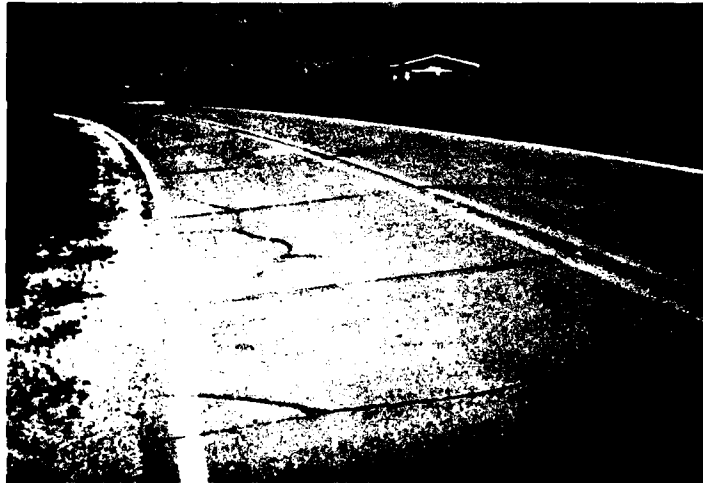
Figure 8.6. Original Base Slab at Clayton Co., Iowa, Showing Broken Up Area.

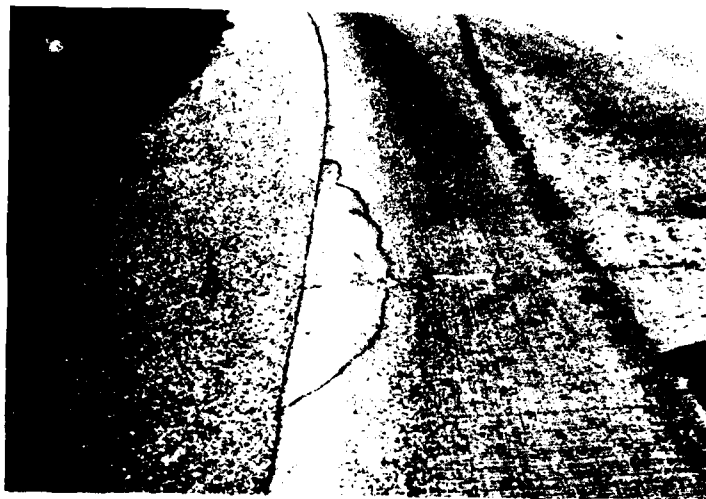
Figure 8.7a. Localized Breakup Area of 2-in. Overlay Cleaned by Water Blasting That Has Debonded at Clayton Co., Iowa.

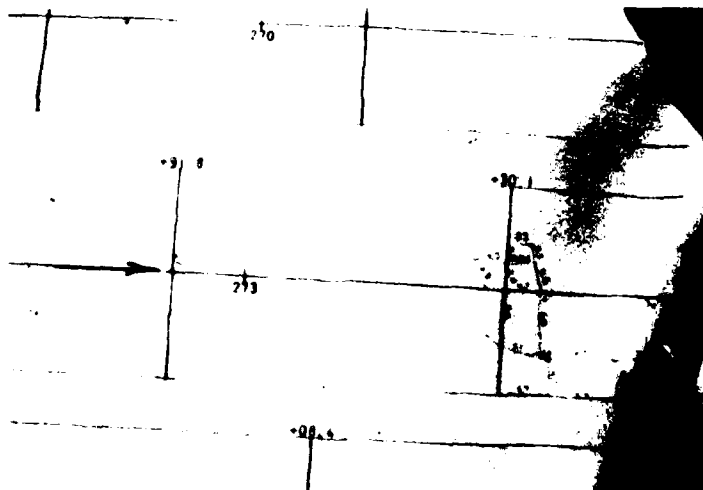
Figure 8.11. Diagram of Crack Pattern in Original Slab, That Reflected Through Overlay.

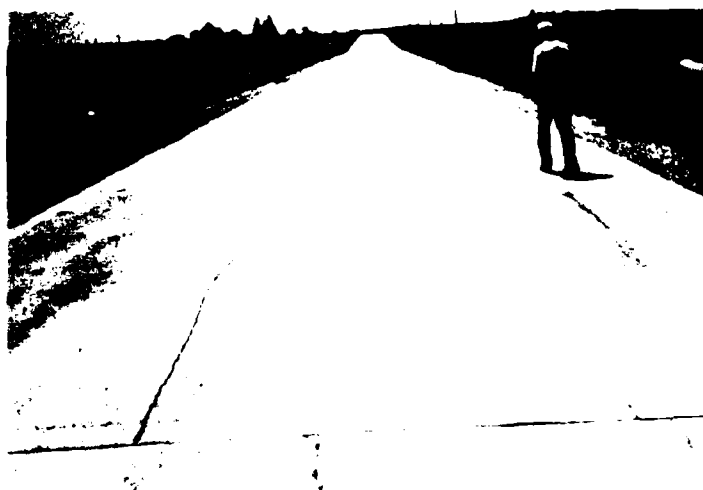
Figure 8.12. Reflective Cracking of 5-in. Overlay in Figure 8.11.

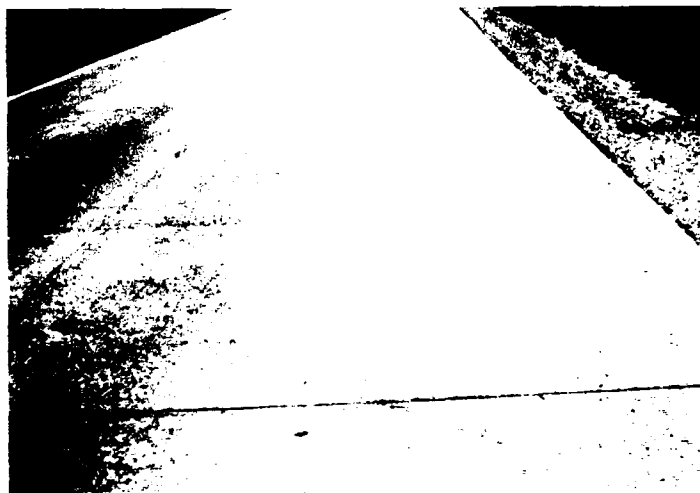
Figure 8.15. No Reflective Cracking in 5-in. Overlay of Slab Shown in Figure 8.14.

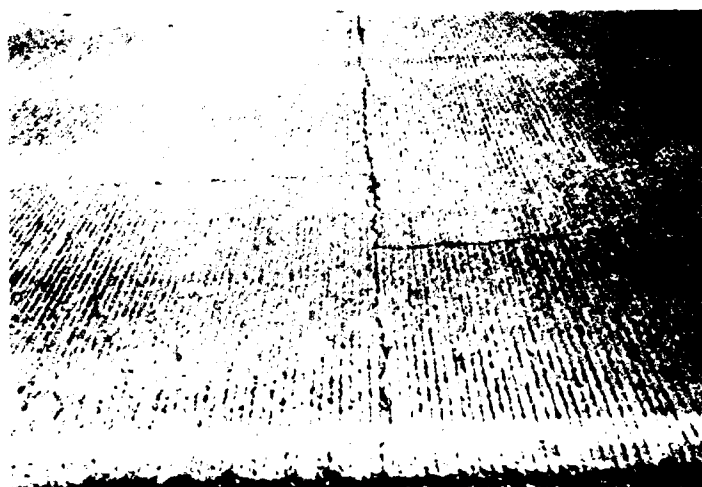
Figure 8.19. Reflective Cracking Through 4-in. Overlay for Slab Shown in Figure 8.17.

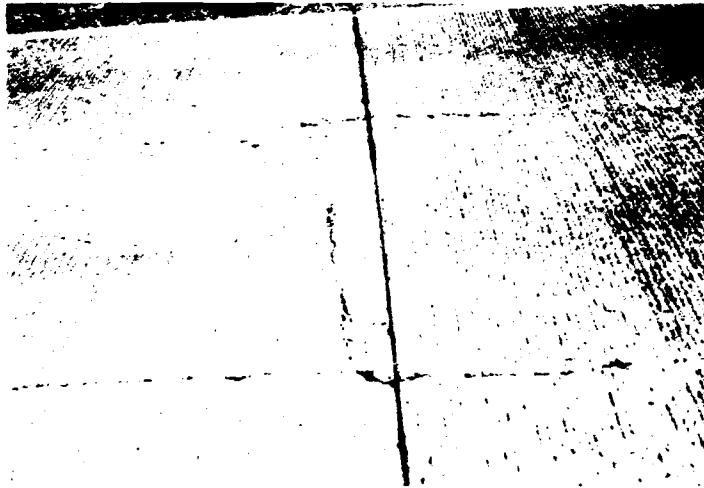
Figure 8.20. Localized Joint Spalling in 4-in. Overlay in Area Surface Caused by Mismatched Joints (Note: There Is a Non-Aligned Joint in the Original Slab Immediately Beneath the Transverse Crack Outlining the Spall).

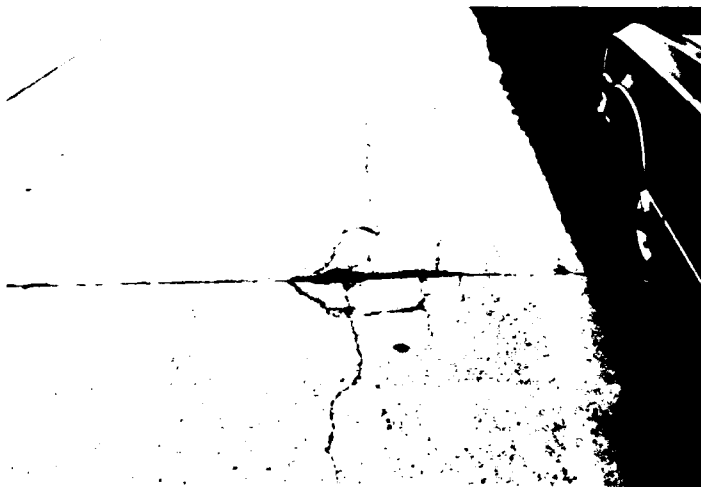
Figure 9.2. Photo of 3-in. Fibrous Concrete Overlay Containing 60 lbs. of 1-in.-Long Fibers Per Cubic Yard of Concrete after 6 Years of Service (Green Co., Iowa, 50).

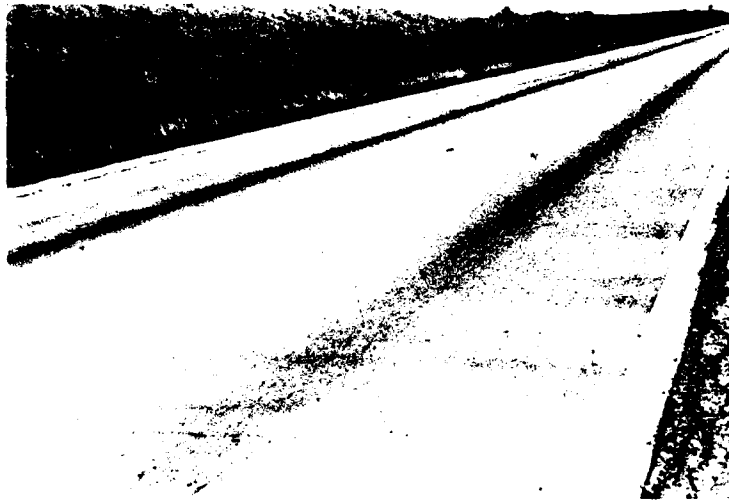
Figure B-1. General Condition of I-80 Shown in the Westbound Lane Which Was Not Being Overlaid at This Time.

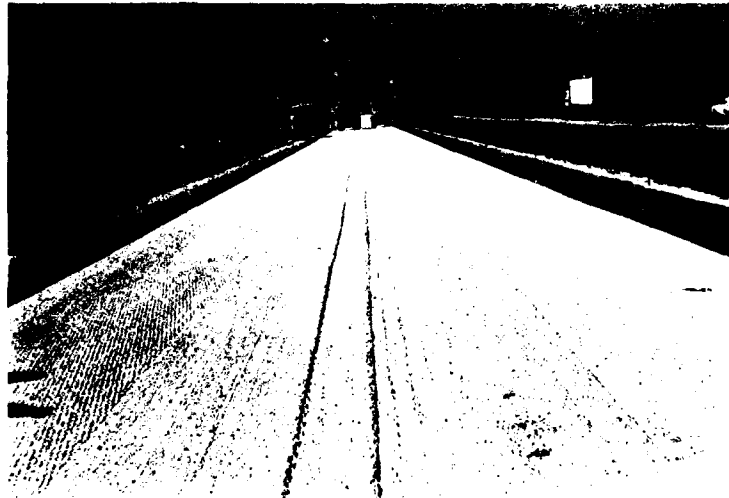
Figure B-2. Roto-Milled and Sandblasted Surface Showing the General Condition of the Prepared Surface. Note the Deeper Milling Along the Centerline.

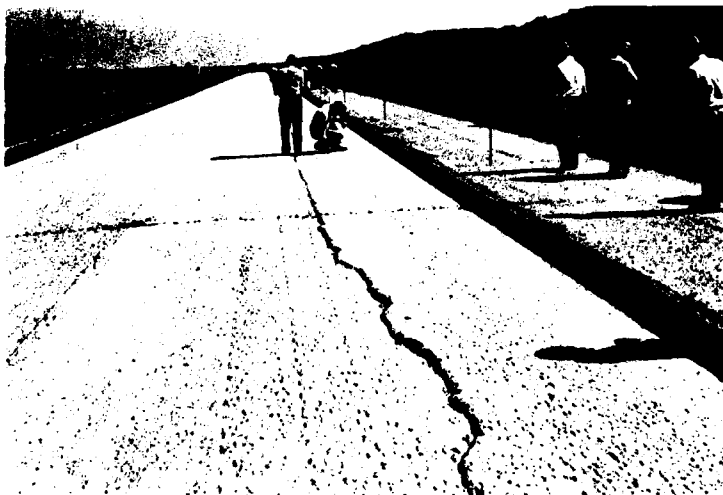
Figure B-6. Major Longitudinal Crack After Milling and Sandblasting. Note the Major Spalled Area.

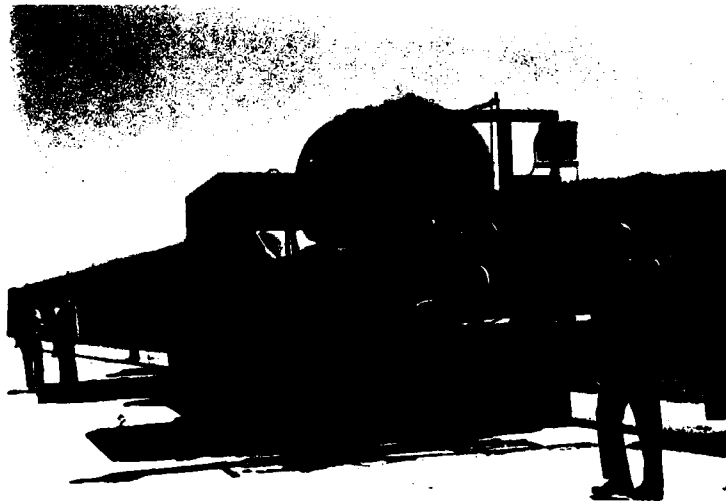
Figure B-8. Overview of Sandblasting Equipment Used on the Project.

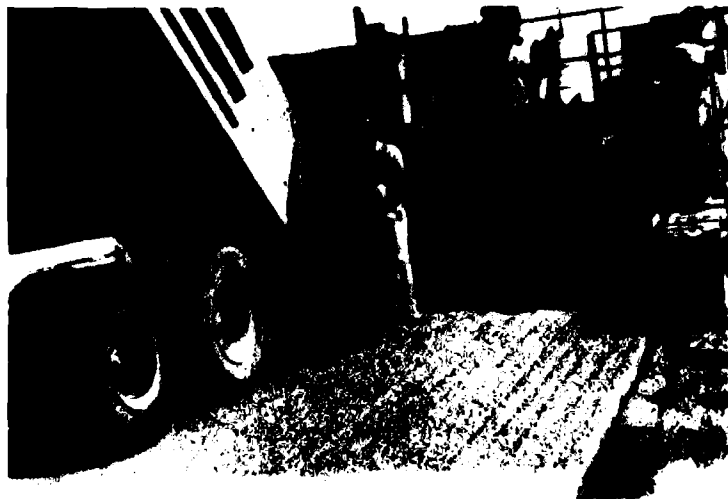
Figure B-12. Front View of Paver With Concrete Truck Rear Tires in Grouted Area. Note the Absence of Any Grout Pickup on the Rear Tires.

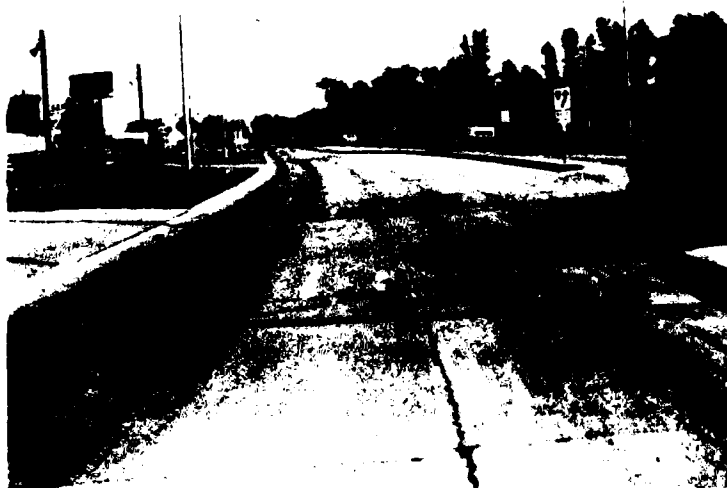
Figure B-16. Overview of Westbound Lanes of Bonded Concrete Overlay With Longitudinal Joint Between Old Existing Outer Slab and Widening Slab--Note Spalling of Reflected Non-Sawed Longitudinal Joint.

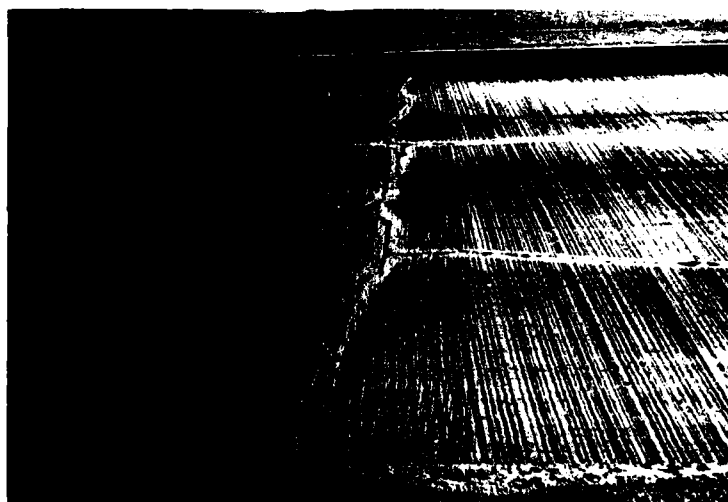
Figure B-20. Transverse and Longitudinal Crack Probably over Existing  
Joints Or Cracks.
